Case Vehicle (A): 2000 Dodge

Type: Dakota SLT, 4 x 4, 2-door pickup

Veh. (B): 1984 Ford

Type: F-250, 4 x 4, 2-door pickup

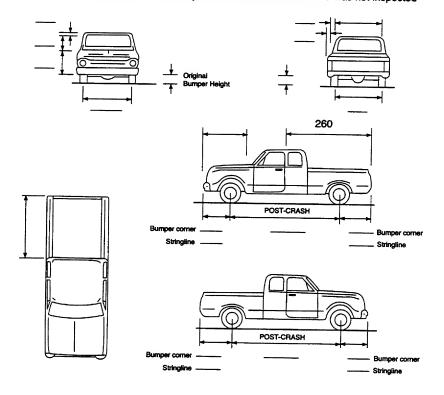
This vehicle was able to be driven away from the accidnet scene and was not inspected

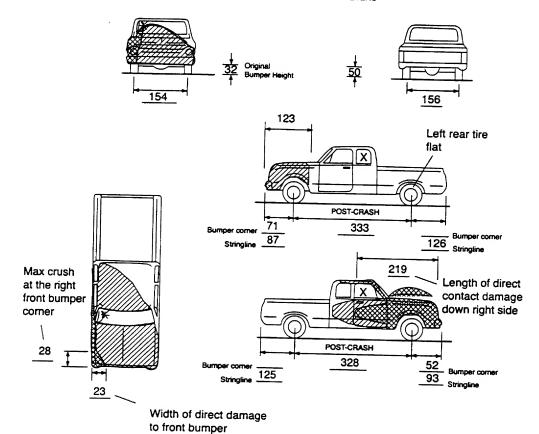
(Slide 3) Damage to case vehicle (A) was moderate. Direct damage began at the right-front bumper corner and extended 23 cm to the left, resulting in 19-percent vehicle overlap. The maximum crush was 28 cm at the right-front bumper corner. (Slide 4) Direct contact damage also extended 219 cm down the right side.

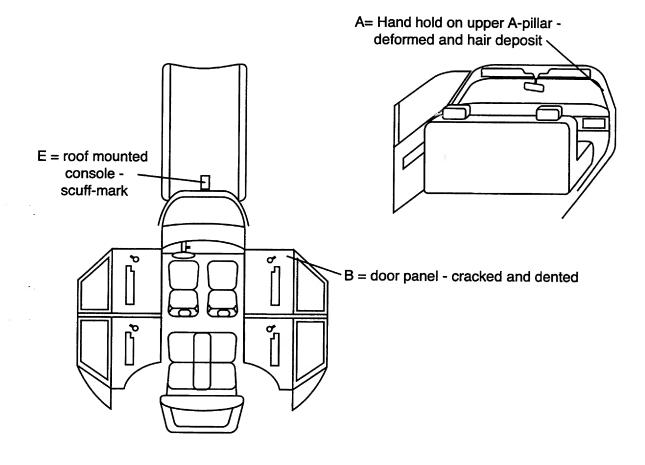
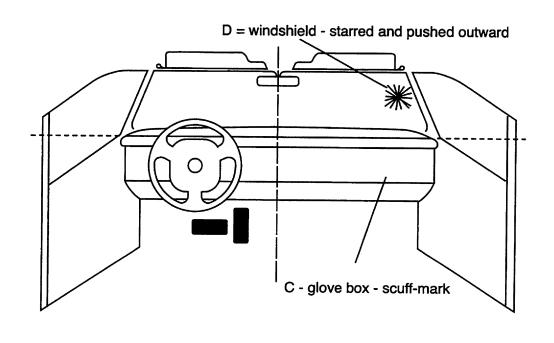
VEHICLE OCCUPANT CONTACT DIAGRAM

Confidence
	Interior	Occupant	Body		Level of
	Component	No. if	Region		Contact
Contact	Contacted	Known	if Known	Supporting Physical Evidence	Point
_	Hand hold	DR	Rt. arm	Deformed and hair deposit	1
A	on upper A-				
	pillar				
- D	Right door	DR	Rt. thigh	plastic cracked and dented	1
В	panel				
С	Glove box	DR	Rt. Leg	Scuff-mark	2
D	Windshield	DR	Rt. hand	Starred and pushed outward	2
	Roof	DR	Head	Scuff-mark	3
E	mounted				
	console				
F					
G					
Н
